SCHEMATIC DIAG
PC501 TX MODULE
ALDA 1 80-40

CONNECTING THE CALIBRATOR MODULE PC 801 TO THE ALDA 103 TRANSCEIVER

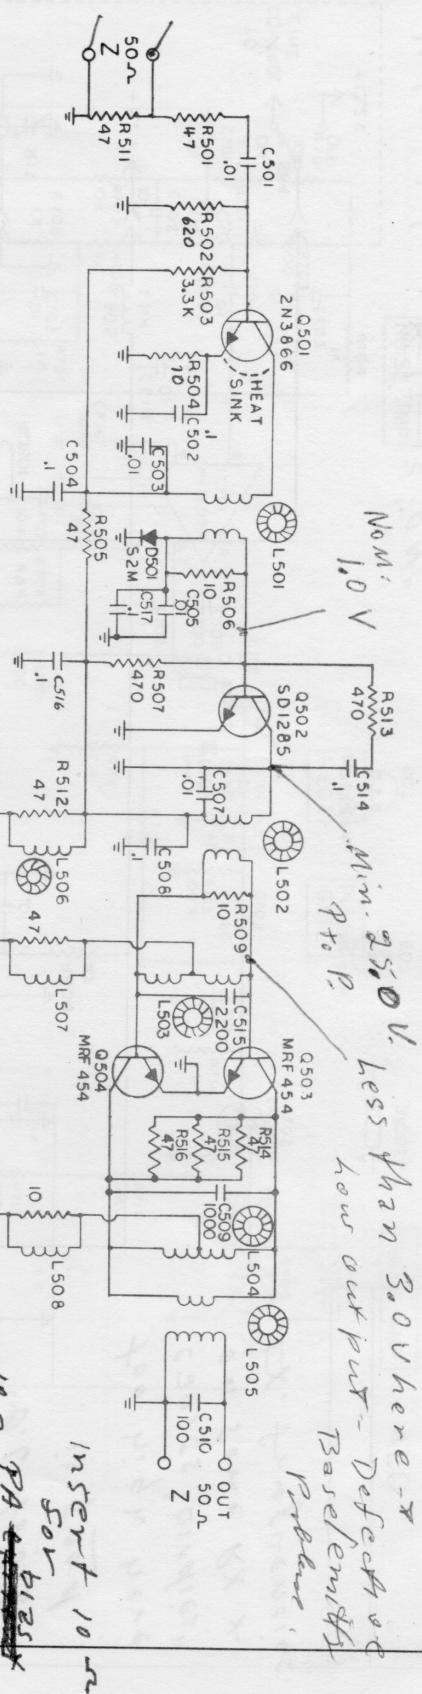
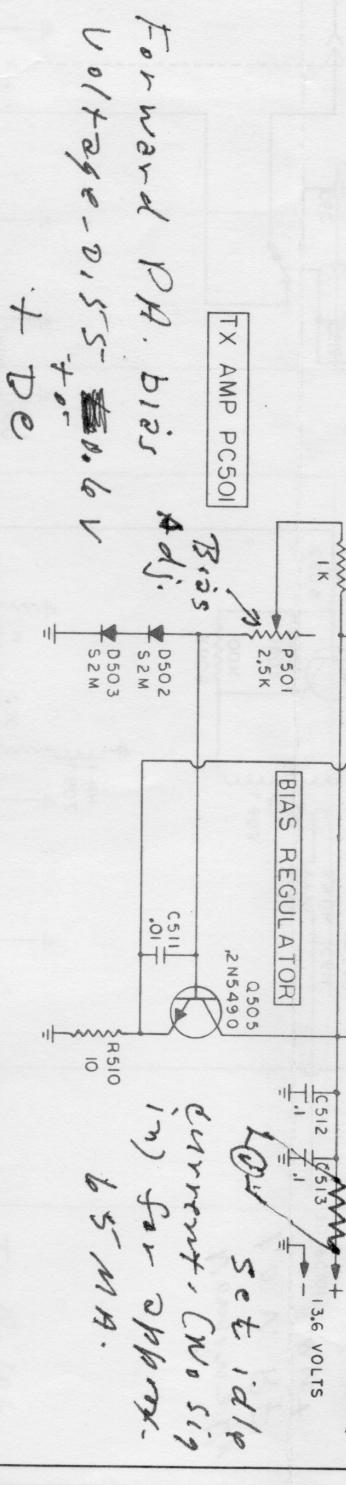
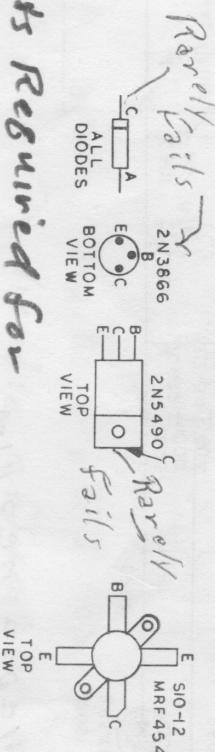
Notes: When tube-shoot-through carrier steps down tx problems remove the T_{B+} (12V) lead from PA chassis and measure input at R_{511} .

Inputs Required for
Gtor Alda. 105 Mod.: 80M-2.7/2.0V, 40M-2.0V, 10M-
2.0M-3.0V + 3.5V, 10M-3.0 to 3.5V

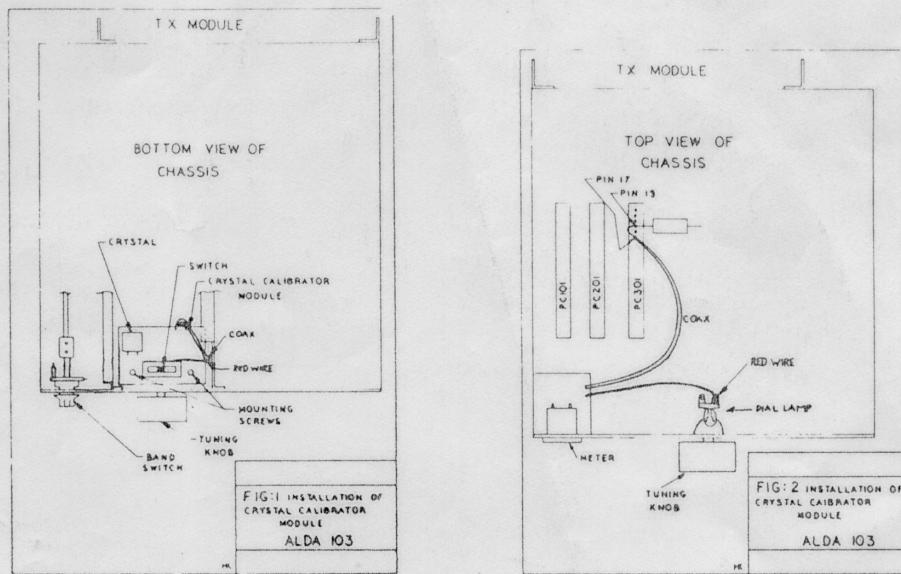
3. Feed the red wire through the opening, past the meter, turn transceiver right side up. Connect the wire to the dial lamp located directly behind the dial. This is a +8.2 volt point and has one other red and orange wire connected to it. Tuck the wire down so that it does not get pinched when the cover is replaced. See Figure 2.

4. Feed the co-axial cable through the opening, past the meter. Turn the transceiver right side up. Connect the co-ax inner conductor to pin 19 of the PC301 PC board connector. (Counting from the front.) Solder the braid to pin 17 of the same socket. See Figure 2 for PC301 location.
